DEPARTMENT OF TRANSPORTATION

Quality Assurance and Source Inspection

Contract #: 04-0120F4Cty: SF/ALA Rte: 80 PM: 13.2/13.9File #: 99.28**WELDING INSPECTION REPORT****Resident Engineer:**Siegenthaler, Peter**Address:** 333 Burma Road**City:** Oakland, CA 94607**Report No:** WIR-019923**Date Inspected:** 03-Feb-2011**Project Name:** SAS Superstructure**OSM Arrival Time:** 700**Prime Contractor:** American Bridge/Fluor Enterprises, a JV**OSM Departure Time:** 1500**Contractor:** Zhenhua Port Machinery Company, Ltd (ZPMC) Chanxing Island**Location:** Shanghai, China

Bridge No: 34-0006**Component:** OBG Segment**Summary of Items Observed:**

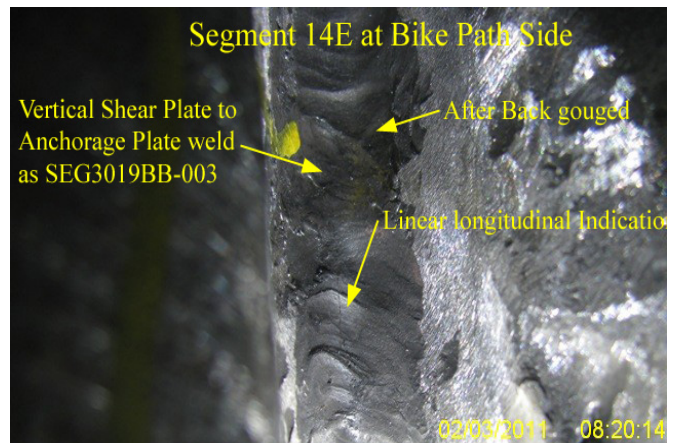
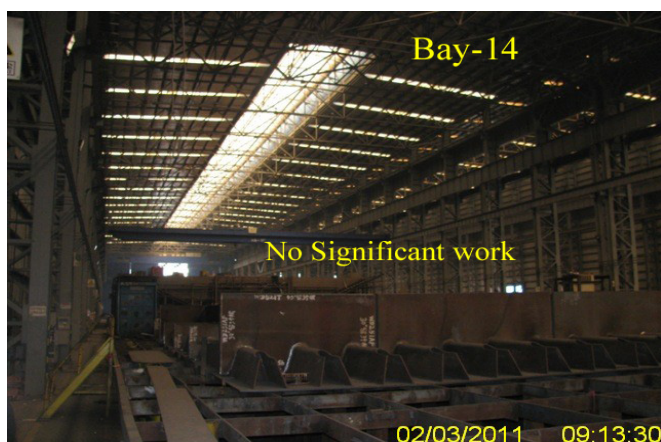
During the random visual inspection of welds located on Segment 14E at bike path side, this Quality Assurance Inspector (QA) observed that Linear longitudinal indication on back gouged area of vertical shear plate to anchorage plate weld. The Linear longitudinal Indication is measured approximately 50 mm in length. This weld is a Complete Joint Penetration (CJP) weld joining the vertical shear plate to anchorage plate weld joint is identified as SEG3019BB-003. The vertical shear plate to anchorage plate weld members is identified as SPCM. This weld is designated as Seismic Performance Critical weld. OBG segment 14E is located south Side of Bay 14 area. QA marked the Linear longitudinal indication near the weld area & also marked the Magnetic particle Testing (MT) of full weld requirements prior to weld. See the attached picture.

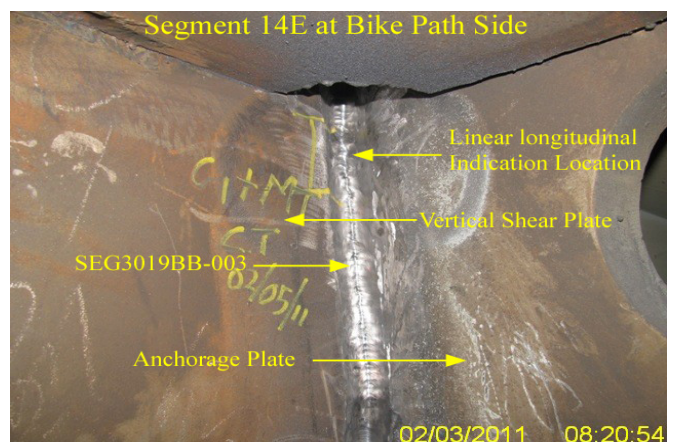
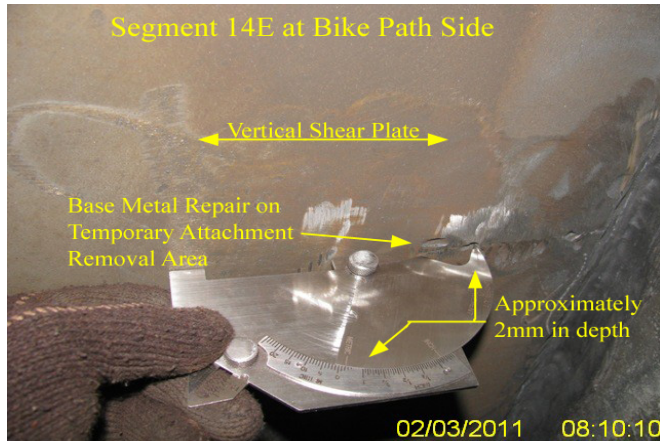
During the random visual inspection of welds located on Segment 14E at bike path side, this Quality Assurance Inspector (QA) observed that base metal removal on temporary attachment removal area of vertical shear plate located near to the vertical shear plate to anchorage plate weld is identified as SEG3019BB-003. The base metal removal is measured approximately 80 mm in length & 2mm in depth. The vertical shear plate to anchorage plate weld members is identified as SPCM. OBG segment 14E is located south Side of Bay 14 area. QA marked the base metal removal on temporary attachment removal area near the weld area & also marked to prepare the weld repair report prior to weld. See the attached picture.
